**Docket No. 217 – Development and Management Plan Inspection**

Northeast Utilities Service Company Certificate of Environmental Compatibility and Public Need for the construction of a 345-kV electric transmission line and reconstruction of an existing 115-kV electric transmission line between Connecticut Light and Power Company's Plumtree Substation in Bethel, through the towns of Redding, Weston, and Wilton, and to the Norwalk Substation in Norwalk, Connecticut.

**Date:** September 13, 2006

**Location:** 115 kV Underground Route

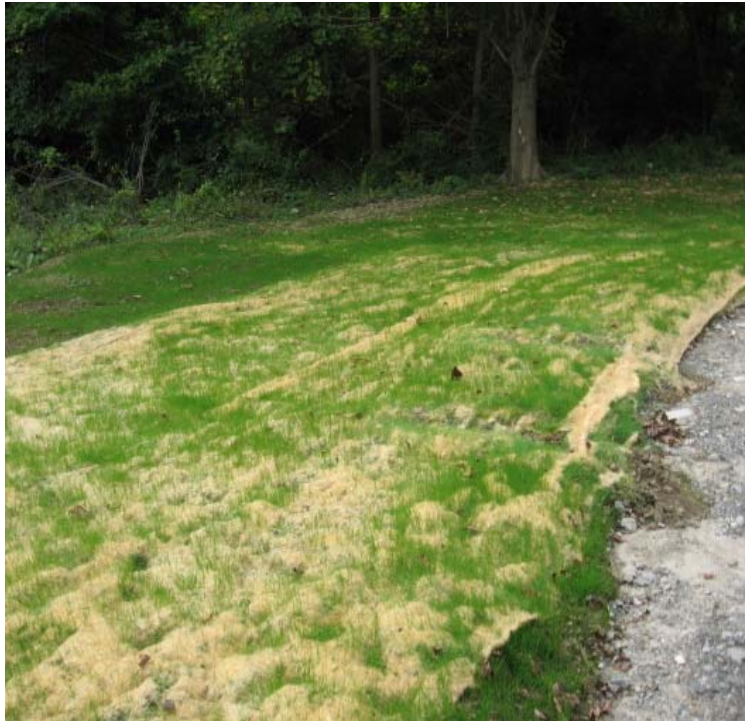
Photo on the left shows the repaired area at the Bethel Ed Park near the south tower. Good grass cover was establishing along the erosion control mat. Photo on the right shows the grass cover at the Hoyts Hill transition structure. The stone drainage swale here is also in good shape. 9/13/06

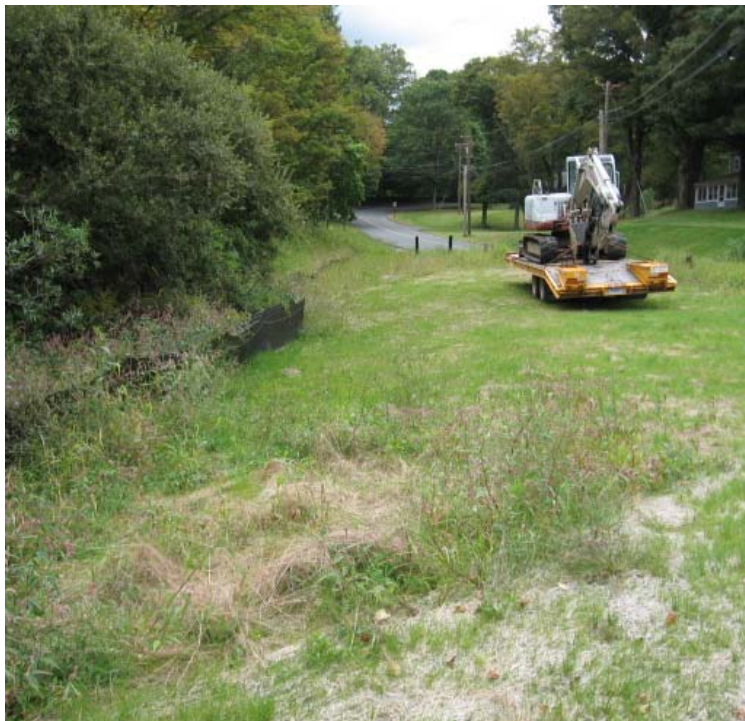
Photo on the left shows vehicles parking at the Sunset Hill Rd area but the area is well vegetated. Silt fence could likely be removed. Photo on the right shows the current conditions of the Putnam Park area, well restored. 9/13/06

- At Sunset Hill Rd. vegetative growth continues at the mats. Equipment was parked there but did not affect the vegetation. 9/13/06	- The entire area is now well restored and appears stable. Remove silt fence when feasible. 9/13/06	N/A
<b>Rt. 107 (Lonetown Rd)</b>	- The Redding CC storage area stone surface remains stable and controls are in good shape. 9/13/06	- None at this time. Evaluate final restoration measures for this area. 6/1-9/13/06	Restore when feasible
<b>Norwalk</b>	-Tracking was noted in the restored area along the	-Overhead contractors should repair this area	N/A
